DEPARTMENT OF TRANSPORTATION

Contract #: 04-0120F4Cty: SF/ALA Rte: 80 PM: 13.2/13.9File #: 69.28**WELDING INSPECTION REPORT****Resident Engineer:**Pursell, Gary**Address:** 333 Burma Road**City:** Oakland, CA 94607**Report No:** WIR-014055**Date Inspected:** 13-May-2010**Project Name:** SAS Superstructure**OSM Arrival Time:** 700**Prime Contractor:** American Bridge/Fluor Enterprises, a JV**OSM Departure Time:** 1900**Contractor:** Zhenhua Port Machinery Company, Ltd (ZPMC), Changxing Island **Location:** Shanghai, China

LAY DOWN YARD.

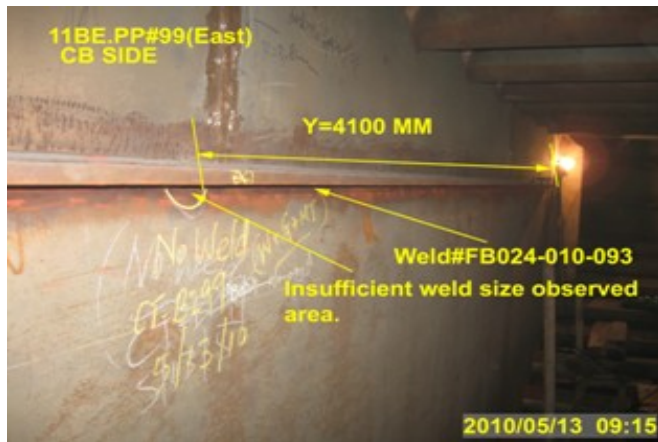
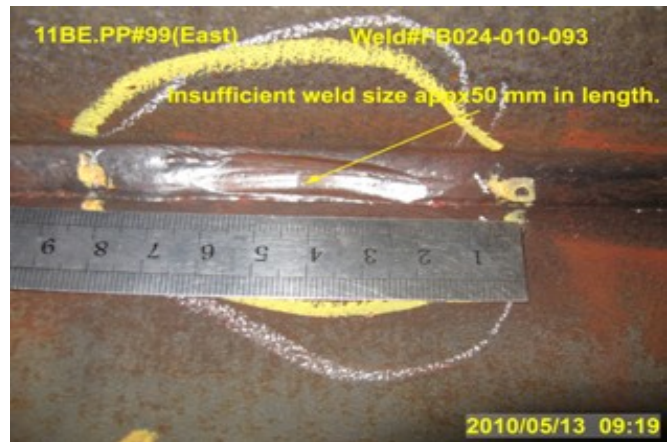
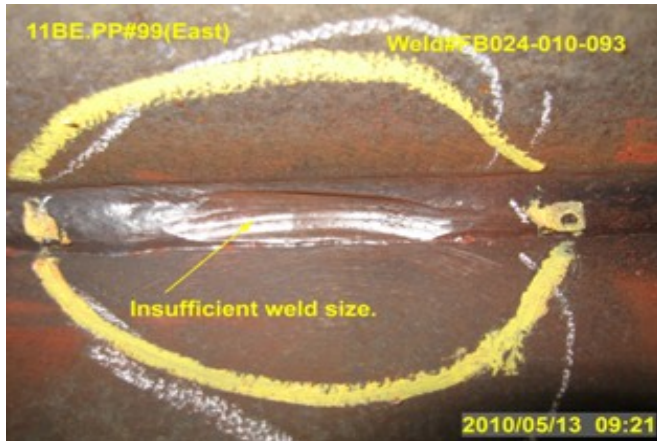
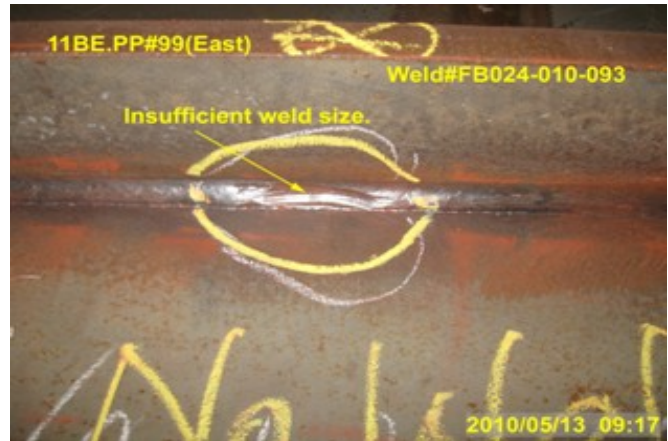
During MT/Visual Testing this QA Inspector observed that the weld size (Excess ground area) was not sufficient at one location. The length is approximately 50 mm. The weld is identified as FB024-010-093. This QA informed to ZPMC QC identified as Mr. Tang Ya Jun of this issue. As per ZPMC QC the area will be repaired by welding and perform MT. Refer attached photos for reference.
